**NBSIR 75-647**

# **Mechanical Tests of FAA-E2491 Airport In-Pavement Approach and Threshold Lights**

Donald C. Robinson

Prepared for  
Federal Aviation Administration  
Washington, D. C. 20590

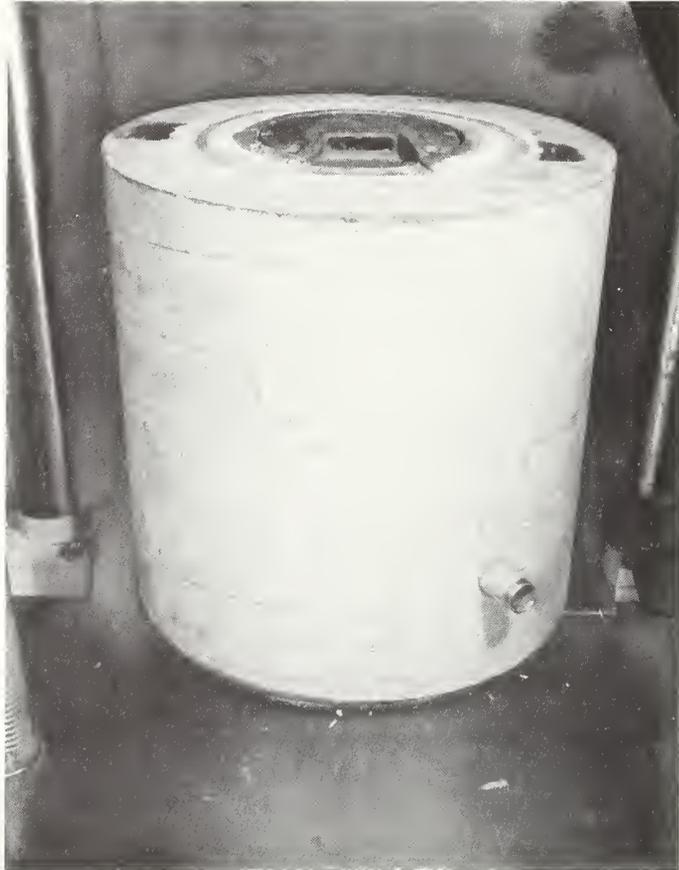
**Figure 2 – Type FAA-E-2491 Airport Marker Light Installed  
in LB-4 Base Encased in Concrete Cylinder**

A schematic of a light unit installed in the LB-4 base encased in a concrete cylinder is shown in Figure 1 and a photograph showing the exposed optical cover assembly and adapter ring for the installed light is given in Figure 2.

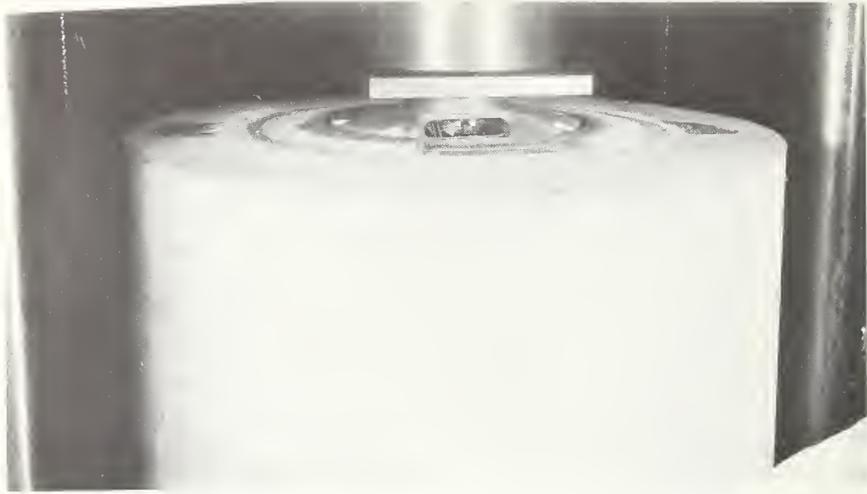
**Figure 4 – Static Test Setup Using 6-Inch Diameter Steel Plate for Loading Top of Light Assembly**

The static load tests were performed in a 400,000 lbf capacity universal testing machine. The LB-4 light base encased in concrete was placed on a 36-inch diameter by 0.75-inch piece of plywood to protect the machine platen. All of the lights were installed in accordance with procedures given in Reference 2. Static loads were applied using either a 6-inch diameter by 1½-inch thick steel plate or using a rubber pad having a Shore A hardness of 55 to 65 through which the loads were transferred to the cover assembly. Figure 4 shows the set-up when using the 6-inch diameter plate. When the rubber pad was employed, it was compressed by a large steel plate which overlapped the top of the optical cover assembly, as shown in Figure 5.

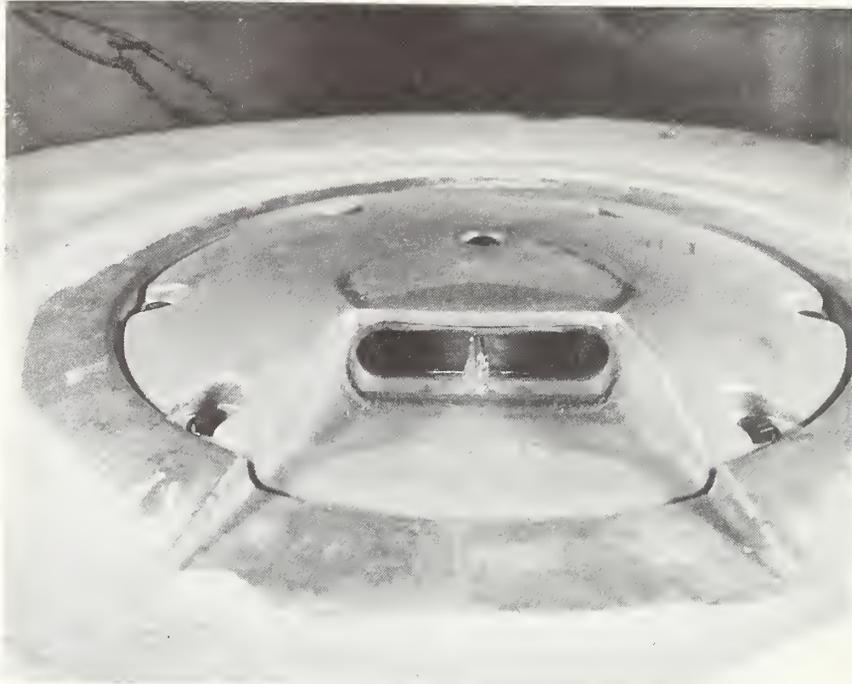
**Figure 7a — Prism Fracture Developed During Static Test of New Style FAA-E-2491 Light**

The principal results of the static load tests are summarized in Table 1. All of the tests on the new style lights were terminated when the glass prism in the optical cover assembly fractured. These fractures all occurred in the center of the prism, as shown in Figures 7a and 7b. The load versus deflection of the optical cover assembly measured when the lights were loaded through the 6-inch diameter steel plate and through the rubber pad is plotted in Figure 8. The strains measured on the cover assembly during these tests are shown in Figures 9 and 10 and the strains measured on the glass prism are plotted in Figure 11. The measured deflection and strain levels at a given load were generally higher for the distributed load (rubber pad) tests than for the concentrated load (steel plate) tests on the new style lights.

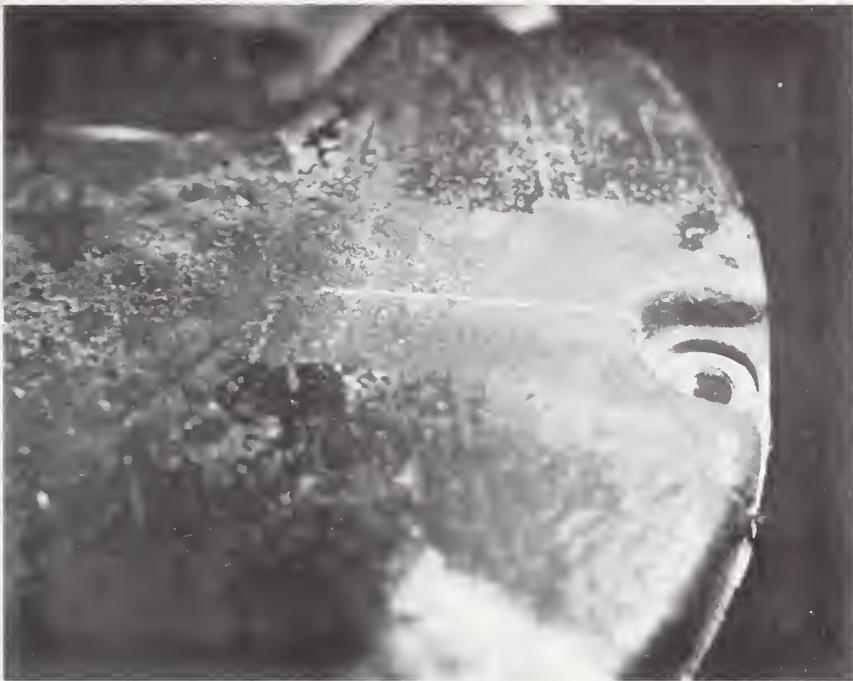
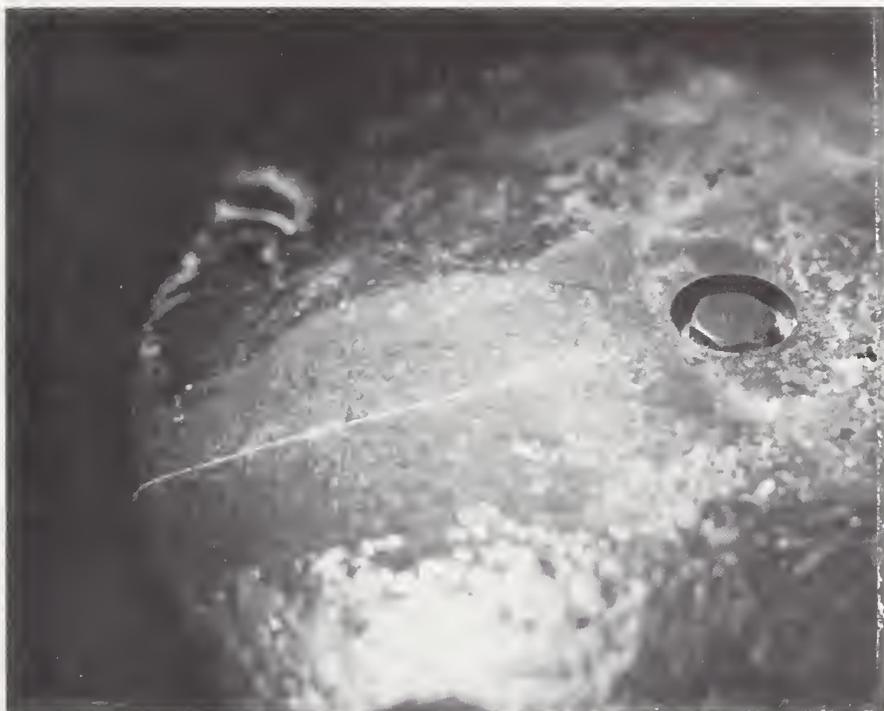
**Figure 12 – Fracture of Optical Cover Assembly of Old Style FAA-E-2491  
Light After Static Test Using 6-Inch Diameter Steel Plate**

During the test on the old style light, Serial No. 267, when the load was applied to the optical cover assembly by a steel plate, the glass prism was displaced from its initial position in the cover assembly and the test was terminated when the cover assembly casting fractured at a load of 316,500 lbf. After this test, the paint was removed from the cover assembly and dye penetrant was sprayed onto the fractured surface. Photographs of the cracks were then taken when the cover assembly was exposed to an ultraviolet light source. Figure 12 shows the two principal fractures which emanated from the topmost surface of the cover assembly and propagated to the edge of the casting.
